Mirage DSK-8
Service Bulletins

For Mirage serial numbers 10001 - 14731

These service bulletins refer to the original Mirage DSK-8 Sampler.

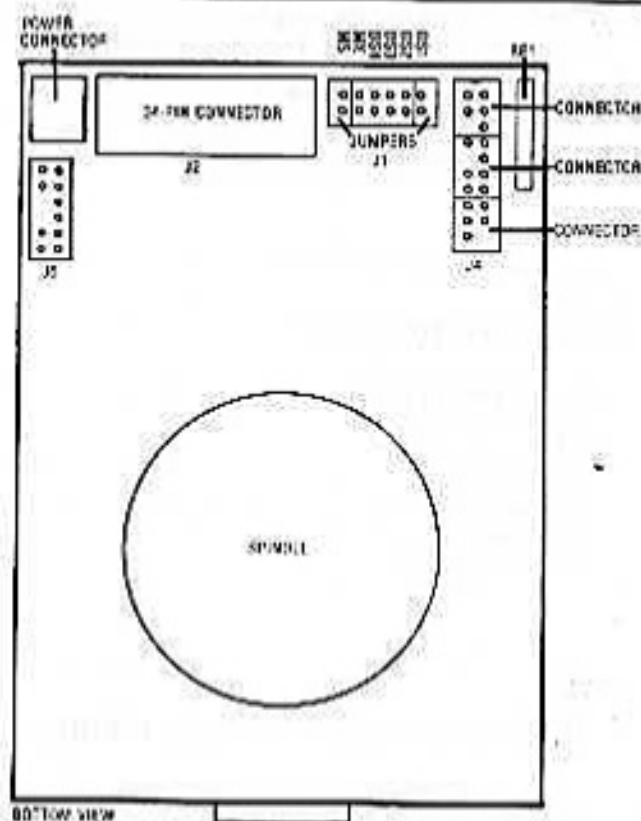
FIGURE 7 - SHUGART SA300 DISK DRIVE

When you have narrowed down the diagnosis to a disk drive problem on Mirages equipped with Shugart Model SA300 drives, perform the following check before returning the drive to Ensoniq.

1. Remove the drive from the Mirage as per the instructions in SECTION D-1 . . . 4 of the Mirage Service Manual.
2. Orient the drive as shown in FIGURE 7.
3. Check the internal connectors of the disk drive at positions J4 and J5 (the J5 connector is one wiring harness while the J4 connector contains 3 separate wiring harnesses).
4. If you find that any of the connectors are not fully seated or completely off the terminals, reinstall the connectors, making sure that they are fully seated.
5. Reinstall the disk drive according to the instructions in SECTION D-5 . . . 8 of the Mirage Service Manual and test the unit.
6. If this procedure corrects the problem, then glue the connectors at J4 and J5 to the circuit board with hot glue.
7. If this procedure does not correct the problem, then the disk drive is bad. Remove the drive and return it to Ensoniq.

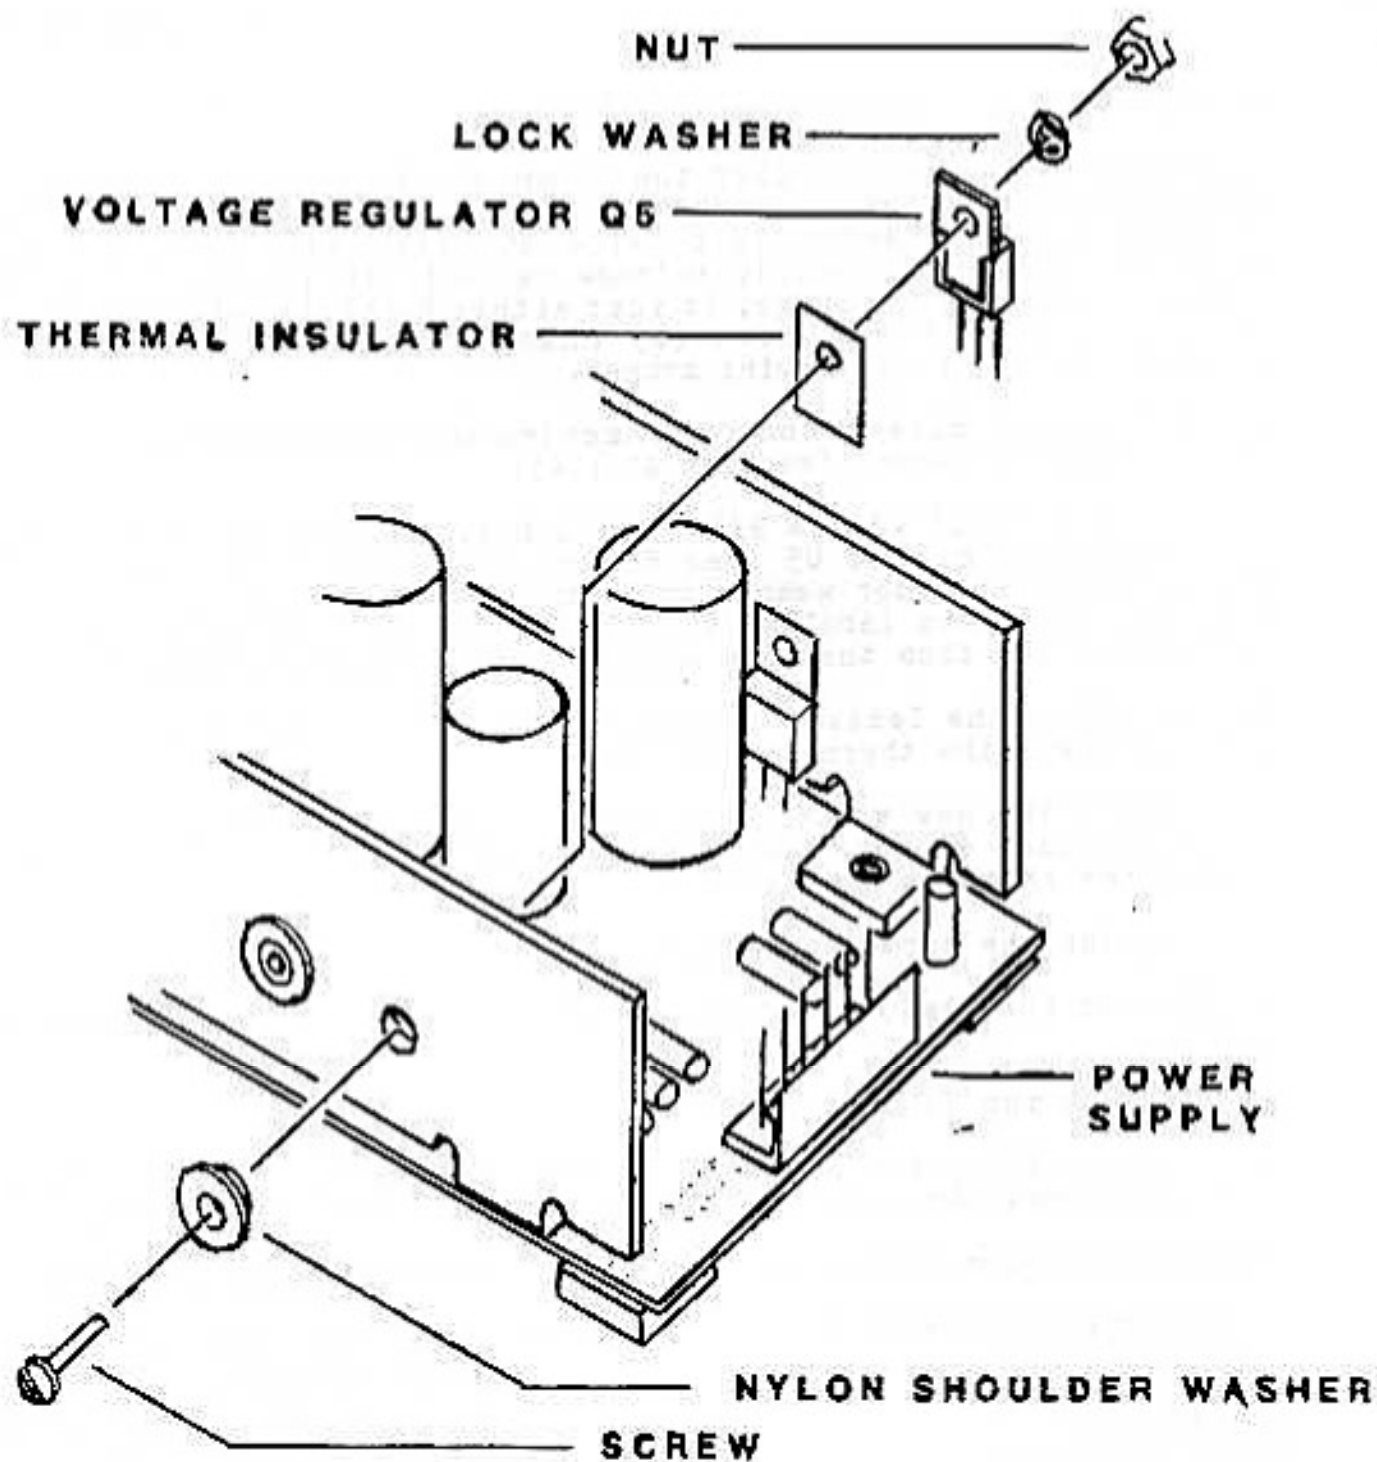
FIGURE 8

When you have narrowed down the diagnosis to warrant replacing the main board, always check the power supply for a +12V DC-8V DC voltage value. (Refer to Service Bulletin #1, section 5 to determine the power supply voltage value.) If the power supply does not have this voltage, it must either be replaced with a new power supply or modified (by changing one of the voltage regulators) in the following manner.

1. Follow the directions for removing the power supply in the Mirage Service Manual (section A1...4).
2. Using a drill with a 9/64" drill bit, drill out the rivet on the regulator marked Q5 (see Figure 8). This is the only one with a nylon shoulder washer on those power supplies which have 5 voltage regulators labelled Q1, Q2, Q3, Q4, Q5. The rivet should be drilled out from the side with the nylon shoulder washer.

3. Desolder the leads of voltage regulator Q5 and remove the regulator and the thermal insulator.
4. Insert the new voltage regulator (7908) in Q5 along with the nylon shoulder washer, the thermal insulator, the screw, nut and lockwasher as shown in figure 8.

5. Tighten the screw on regulator Q5.
6. Solder the leads of regulator Q5 on the bottom of the power supply.
7. Inspect for solder joints.
8. Replace the power supply as per the directions in the Mirage Service Manual (A5...6) and allow to burn-in for a few hours.

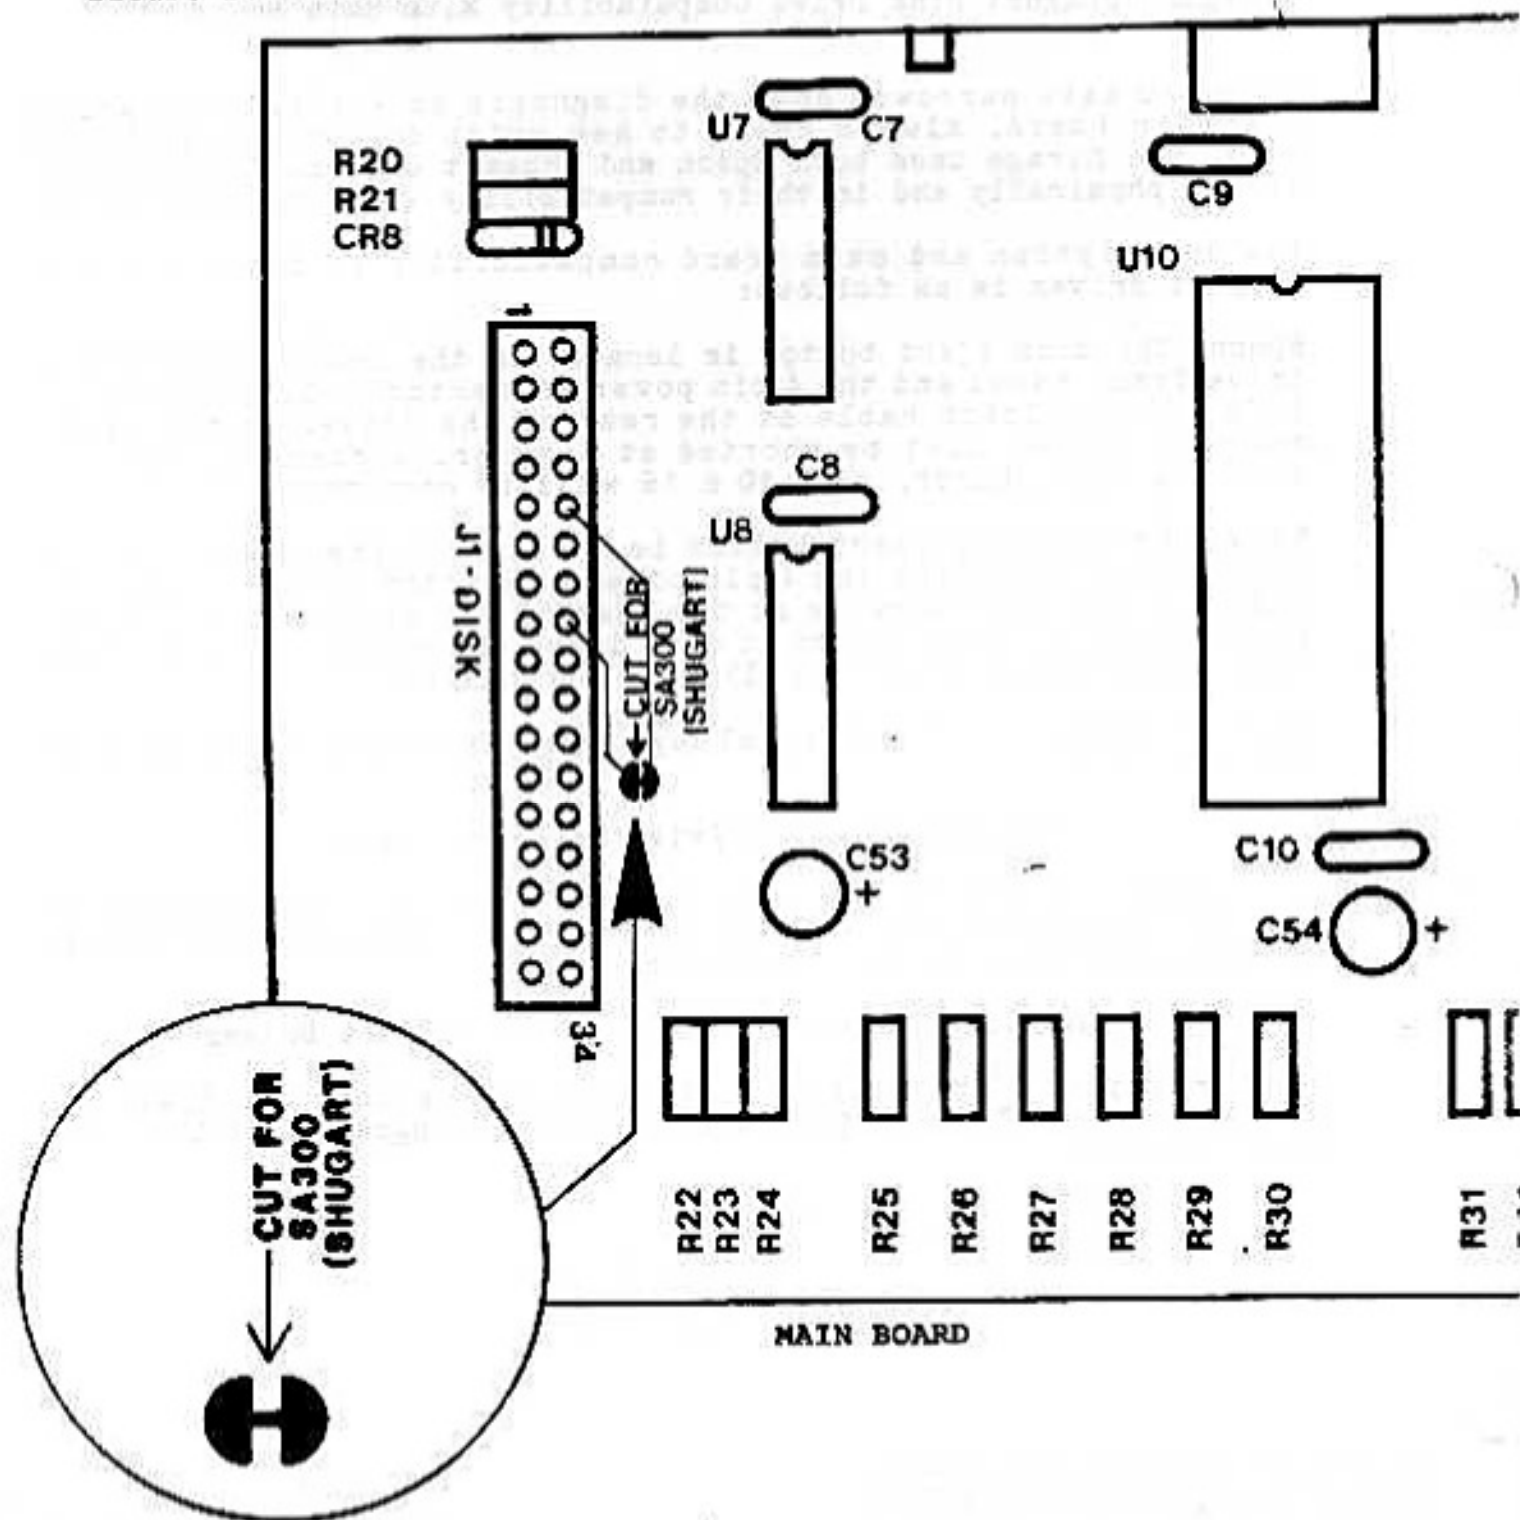
When you have narrowed down the diagnosis to warrant replacing the main board, always check to see which disk drive is being used. The Mirage uses both Epson and Shugart drives. These drives differ physically and in their compatability with the main board.

Epson: The disk eject button is located on the lower right of the drive front panel and the 4 pin power connector is located to the left of the ribbon cable at the rear of the drive. On the main board a jumper must be shorted at disk drive connector J1 (by shorting this jumper, pins 10 & 16 will be connected).

Shugart: The disk eject button is located in the center of the drive front panel and the 4 pin power connector is located to the right of the ribbon cable at the rear of the drive. On the main board a jumper must be out at disk drive connector J1 (by cutting this jumper, pins 10 & 16 will not be connected).

The jumper should be cut with a Xacto-Knife (or equivalent) as per instructions in the blow-up of the Disk Drive selector jumper on the other side of this bulletin.

Make the cut on this thin trace that runs between the two pads for the disk drive selector jumper. If the trace is cut at both ends where they connect to each pad it can be peeled off the circuit board using a xacto knife (or equivalent type of knife). This will yield a clean jumper cut and will leave the solder pads intact for future reconnection.

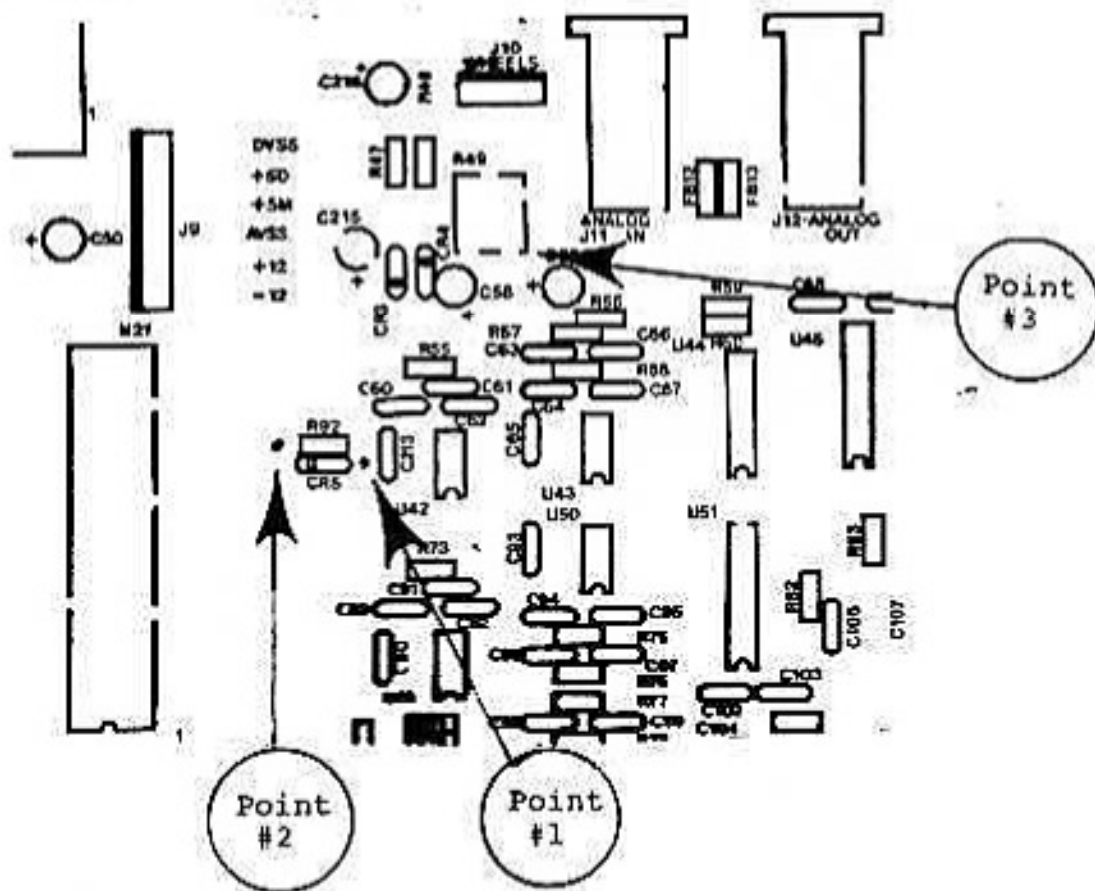
When replacing the Mirage Main Board or the Mirage Power Supply, careful attention must be given to re-adjusting the trimpot located at R49 (Point #3) on the main board. This trimpot sets the volume reference voltage going into the "Q" chip (U21) and if it is not set properly, audio distortion is likely to occur. R49 is located in the upper right hand side of the board, to the left of the Analog-In jack (J11) and directly below the Pitch/Mod Wheel connector, (J10).

The voltage reference point can be accessed by placing the positive probe of your meter on the right lead of CR5, a diode located on the lower right of R92, (point #1). Place the negative probe to Ground, the left lead of R92 (point #2). Adjust the trimpot (point #3) until the meter reads 50 millivolts, or .050 VDC.

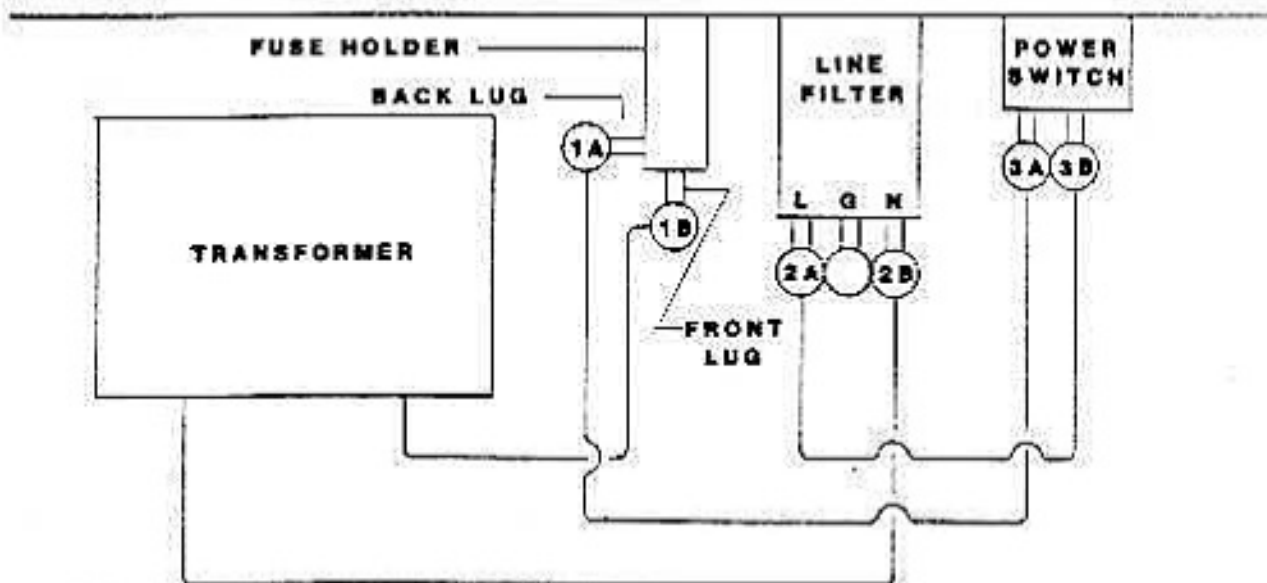
3A

AC LINE VOLTAGE CHECK POINTS
WIRING FOR EARLY MODEL CASE (WHERE TRANSFORMER IS ON THE LEFT).

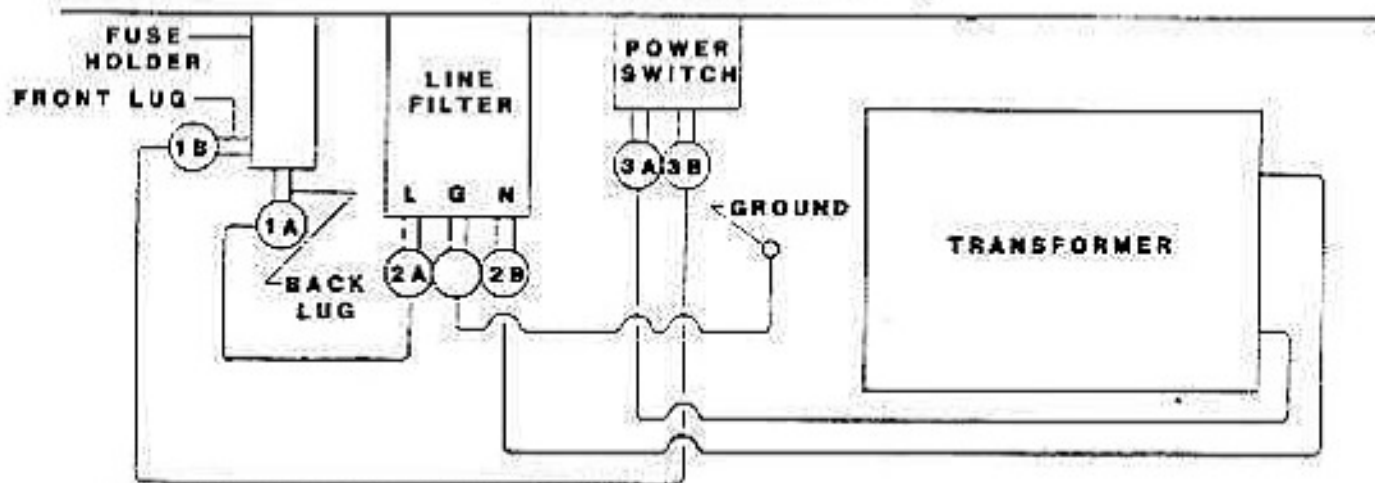
3B

AC LINE VOLTAGE CHECK POINTS
WIRING FOR LATE MODEL CASE (WHERE TRANSFORMER IS ON THE RIGHT).

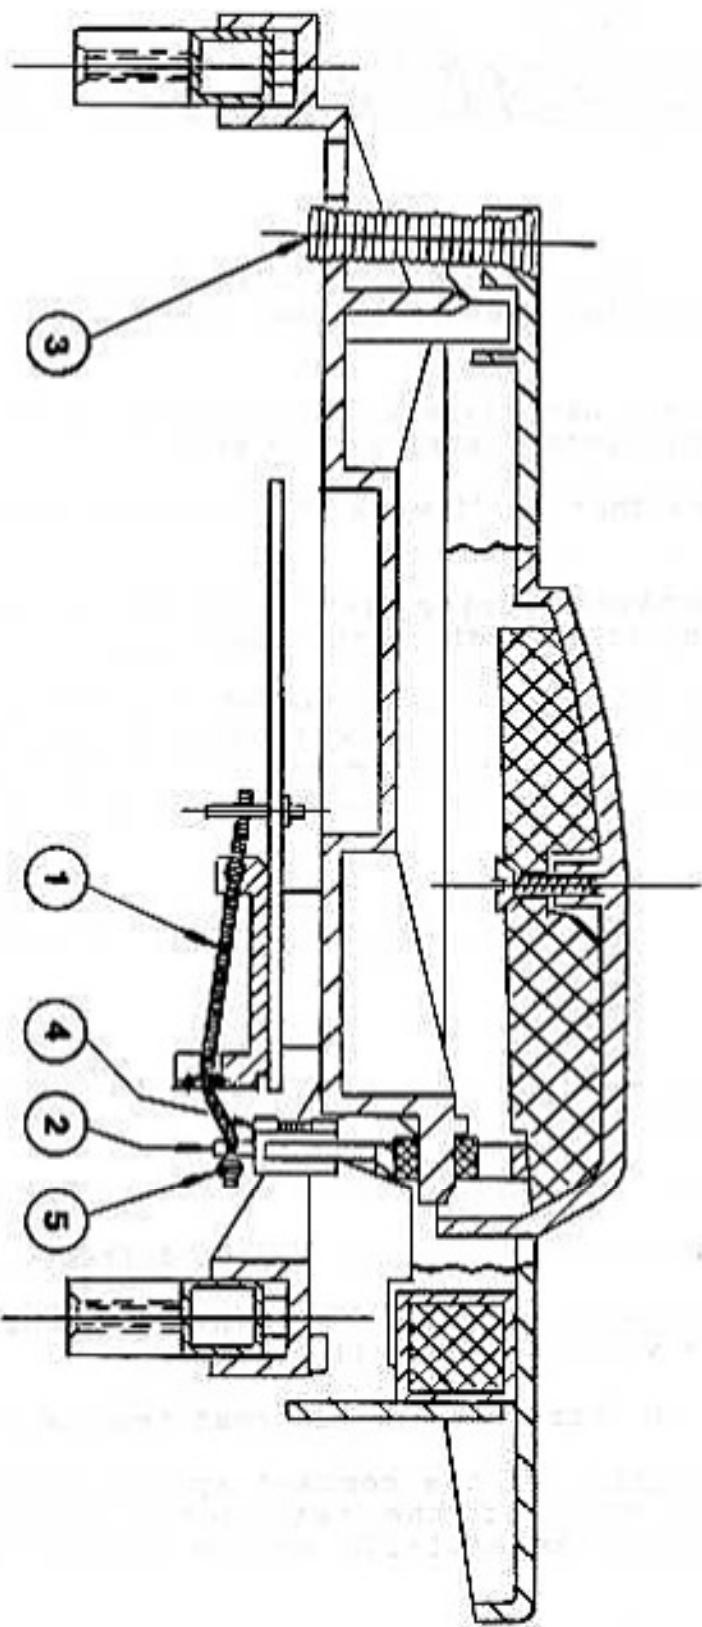
FIGURE 1

Diagnosis: Notes that don't work and/or sound immediately upon boot-up.

Cause: The contact spring may come loose from the front retainer, causing it to rest on the lower contact bar.

Solution: While the spring is detached from the nylon retainer, tin the ball end of the spring with a small amount of solder. Carefully replace this end into the retainer. The solder will prevent the contact spring from working its way through the retainer. Fig 1, item 5.

1. Detach contact spring from nylon retainer. Fig 1, item 1 & 2.
2. Remove rear tension spring from keyboard frame. Fig 1, item 3.
3. Slide key forward, up and out. (When replacing black keys first remove the white keys on either side.)
4. Seat new key on frame and install rear tension spring.
5. Adjust the height of the contact spring retainer so it is level with the rest of the retainers. This will ensure consistent velocity sensitivity across the keyboard. Fig 1, item 4.
6. Replace the contact spring into the retainer.
